Institute of Paper Science and Technology

Technology Transfer Fact Sheet

Corrosion and Materials Engineering Assistance

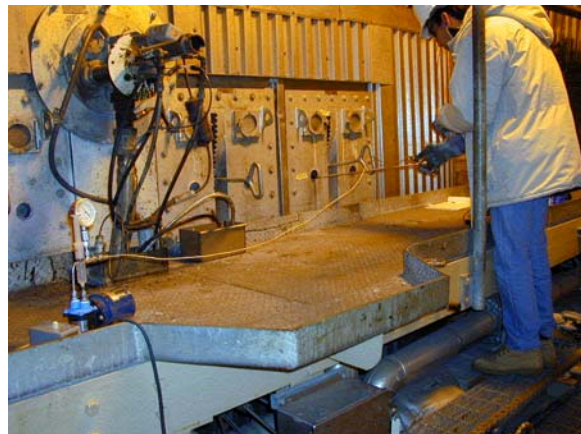
Figure 1. In-situ monitoring of high-corrosion areas.

A major focus of the Unit's current research efforts is on the kraft recovery boiler. Strategies differ for each area of the boiler depending on the materials and the environmental conditions. For instance, certain areas of the lower furnace corrode at higher rates than others. In-situ monitoring carried out in a number of boilers in high- and low-corrosion areas has enabled IPST's experts to characterize the problem (see

Figure 1). Identification of the gaseous environments responsible for the high corrosion rates has allowed them to develop new insights into the mechanisms involved and to develop robust mitigation strategies.

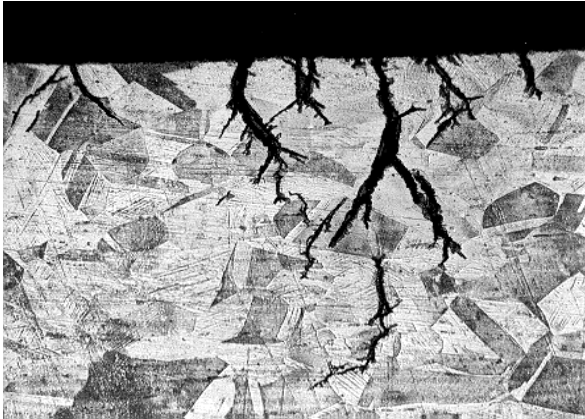
Figure 2. Stress corrosion cracks in stainless steel in dilute wash water.

The Corrosion and Materials Engineering Unit is collaborating with Oakridge National Laboratories to identify conditions that promote stress corrosion cracking in the stainless steel layers of composite floor tubes during recovery boiler shutdowns (see Figure 2). As a direct result of this research effort, IPST's experts can provide member company mills with operating guidelines to help avoid stress corrosion cracking in floor tubes in the future.
